Safety Inspection Report

Annual Inspection

Wickham Market Village Play Area

21 September 2023

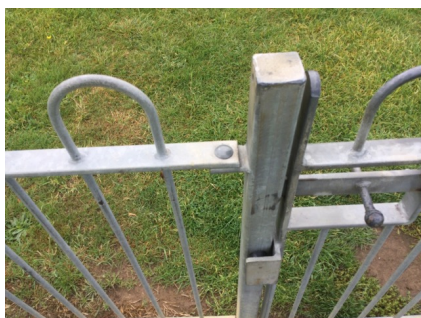
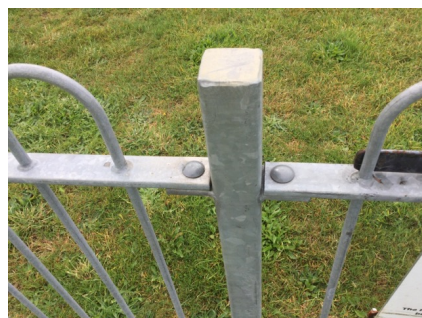
Bolt(s) loose.

Tighten all loose fence panel bolts.

Tighten.

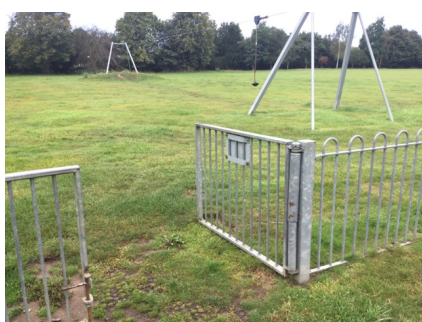
Gate is sticking on the ground.

Gate closest to cableway.

Adjust.

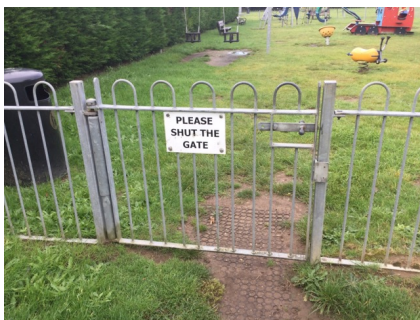
Gate has violent action.

Gate adjacent to car park.

Adjust to remove the hazard.

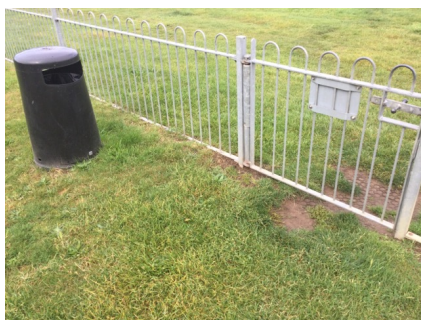
RoSPA recommends that litter bins should not be closer than 2 m from seats and gates (max of 3 m recommended). If they are too far away they may not be used. If they are too close this may cause nuisance from wasps.

Move the bin or seat as appropriate.

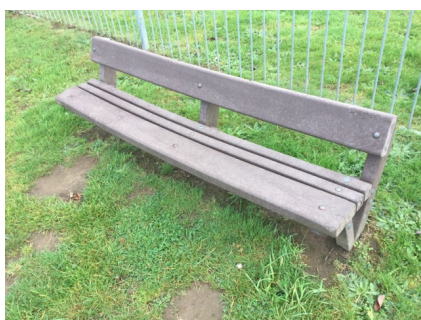
Loose in ground.

Bench adjacent to car park is slightly loose in the ground. Reset.

Reset.

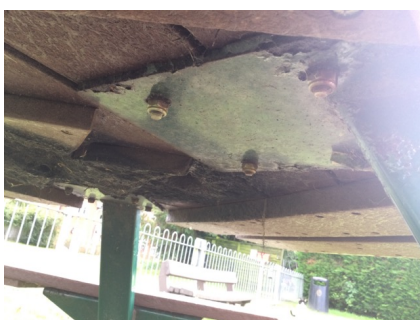
Projecting bolt thread.

Cut back unused bolt thread.

Cut off and file down to remove sharp edges or use the correct length of bolt.

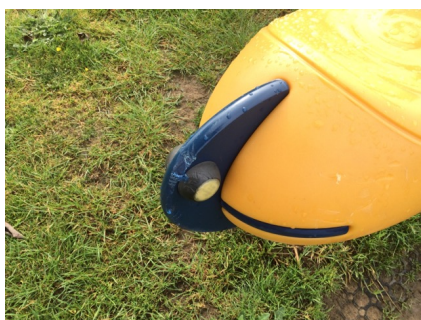
Item is cut.

Several cuts to panels.

Repair.

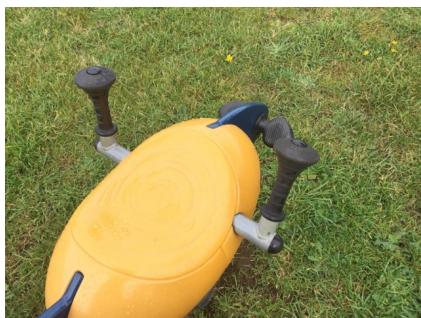
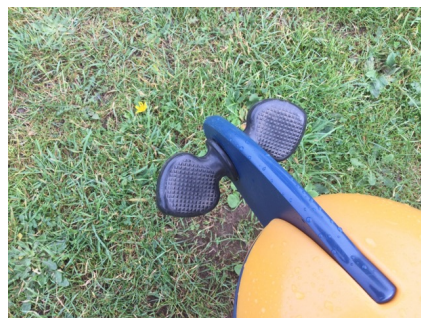
Bolt(s) loose.

One hand hold and both foot holds are loose. Tighten.

Tighten.

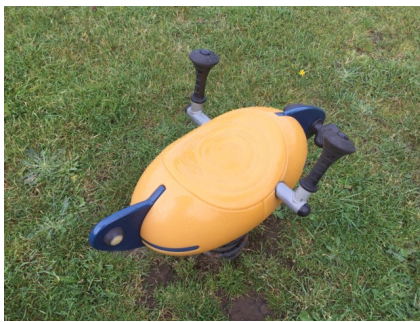
Water is located within the rocker body. Our inspector recommends adding drainage holes to the equipment. However, contact the manufacturer for their comments as this may affect the warranty.

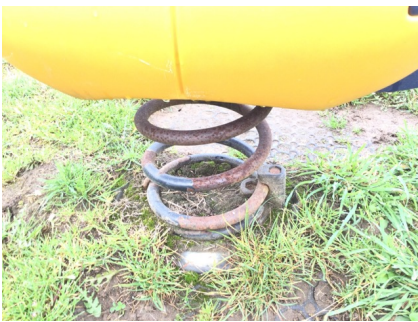
The spring is rusty. These have been known to fail without warning, leading to a collapse of the unit.

Spring has a significant amount of rust. Replace. This was notified on the 2022 inspection report.

Replace.

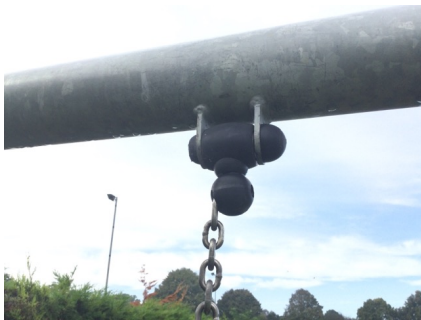
The covers should be removed from the fitting at the top of the chain annually and the shackle bolt should be checked for wear. Check the security of the fittings too.

Replace at 70% of original diameter (30% wear).

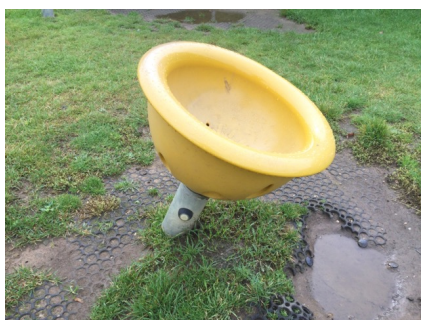
Bearings are worn.

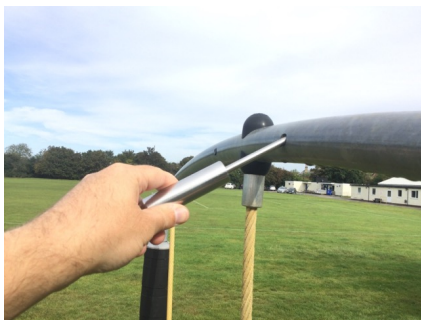
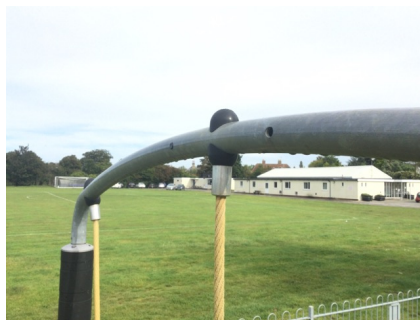
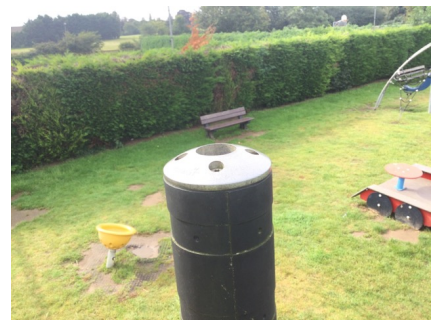
Cap missing.

Plugs / caps are missing from rope climber section top bar creating a potential finger entrapment.

Flag pole / cap is missing allowing water ingress into the frame. Replace.

Replace.

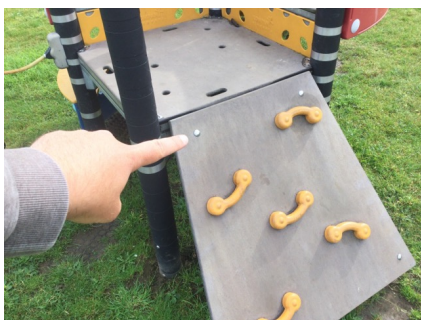
Bolt(s) loose.

Climber ramp is slightly loose to the platform. Tighten.

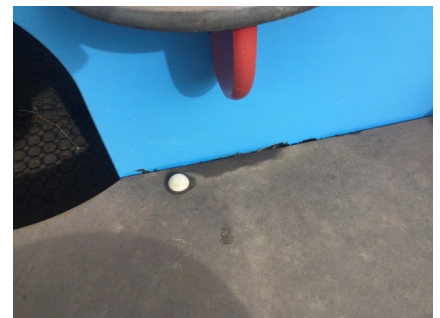
Laminate damaged.

Laminate sections are slightly damaged. Repair.
Consider replacing front laminate and wheel laminates due to levels of damage.
Strimmer damage is present. Prevent further damage.

Rub down and treat damaged edges., Read the notes for further action.

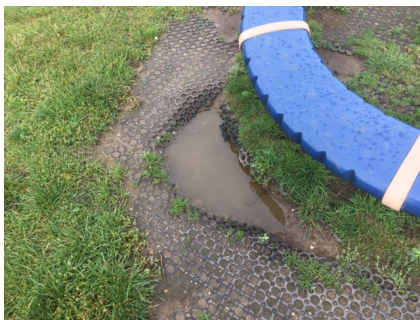
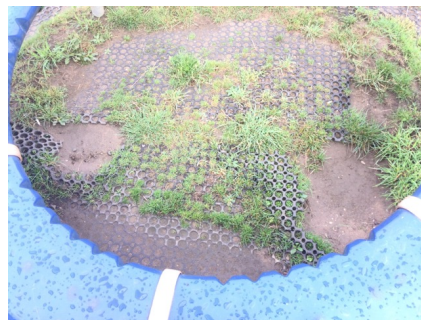
Item is damaged.

Grass mats are damaged around equipment creating potential trip hazards. Replace and secure.

Replace., Repair.

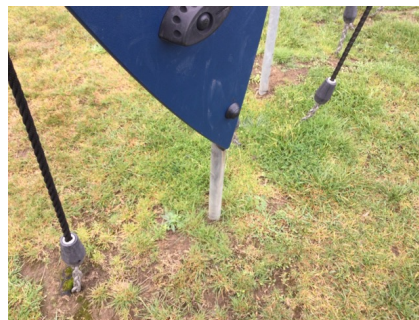
Bolt(s) loose.

Traverse climbing wall section on Multiplay is loose to the metal foundation bar. Tighten.

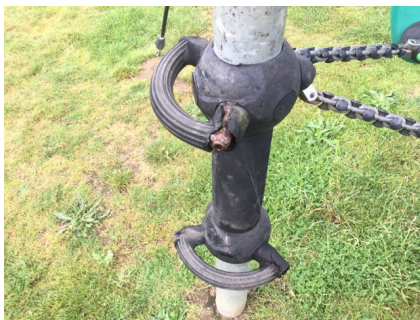
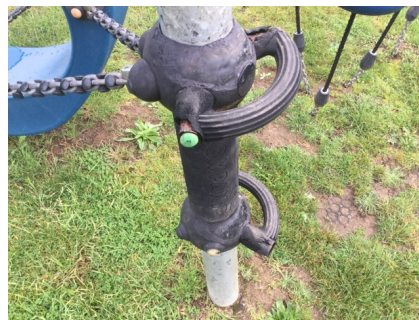
There is significant corrosion on this item.

Multiple hand and foot holds are rusty leaving sharp metal edges projecting. Replace.

Replace the item.

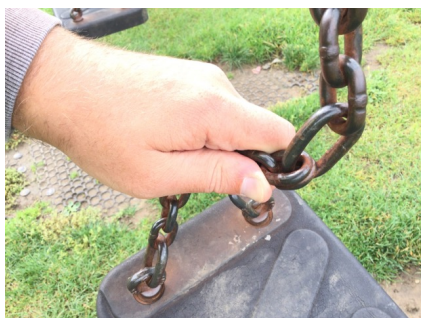
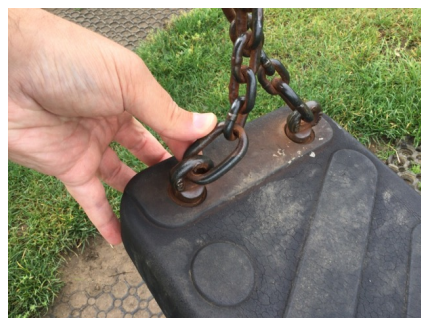
Some chain wear.

Chain links are wearing. Monitor and replace when necessary.

Monitor for further deterioration and replace before 40% wear.

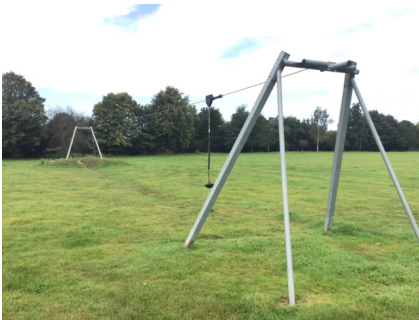
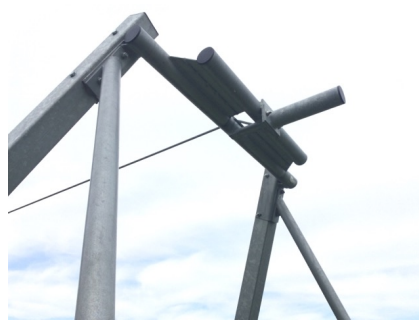
Cables have been known to fail under load due to wear and corrosion. This is generally where the cable enters into a tube, top bar, sleeve or similar, where the wire is in contact and wears and frays over time, but can happen anywhere on the cable. It is important to inspect any hidden parts at least annually. Damaged cables require replacement. This cannot be determined during an annual inspection, and is excluded from our inspection. This can lead to a high risk if no action is taken. Refer to the manufacturer's instructions to ensure the correct check is carried out.

Conduct an appropriate dismantling inspection according to the manufacturer's instructions, and at least annually. The trolley mechanism can be checked at the same time.

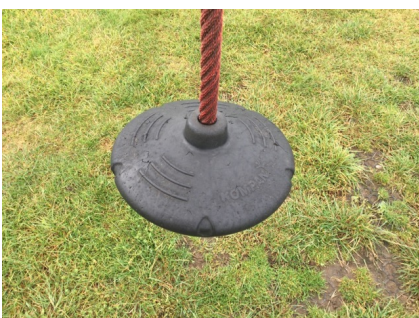
Item has dog damage.

Dog damage present on cableway seat. Monitor and replace when necessary.

Repair.

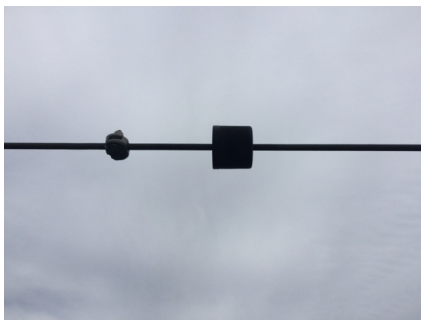
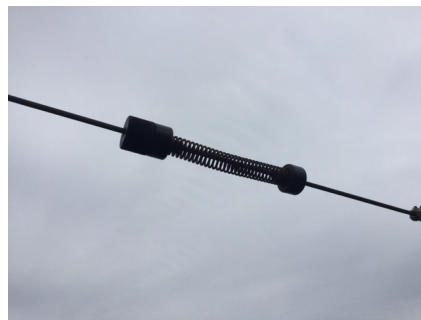
Both Rubber dampeners and springs are loose and can easily move from cable.
Secure.

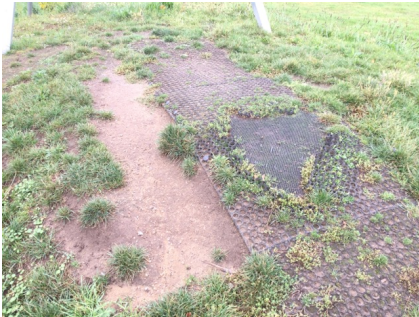
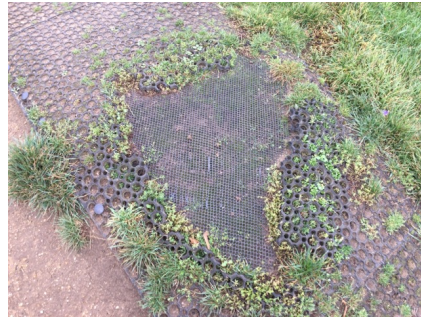
Surface needs repair.

Surface is uneven throughout. Repair.

Grass mats are damaged and lifting creating a potential trip hazard. Replace and secure.

Repair., Replace.
