Safety Inspection Report

Annual Inspection

Wickham Market Village Play Area

21 September 2023

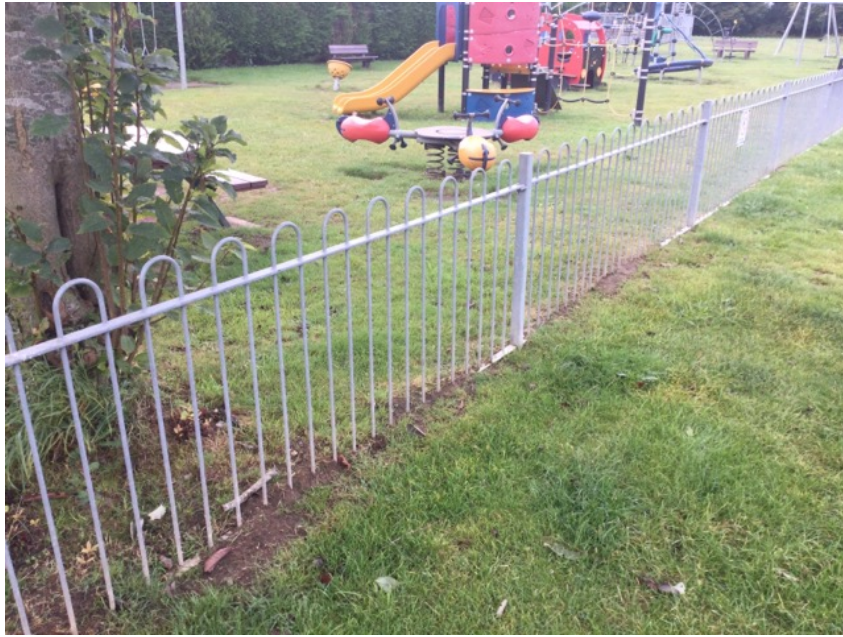
Fencing

Bolt(s) loose.

Tighten all loose fence panel bolts.

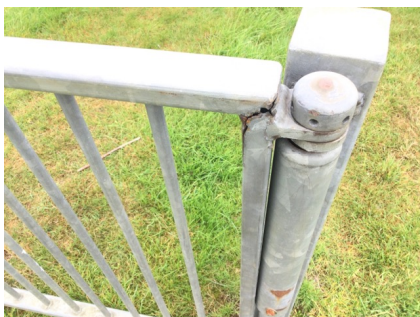
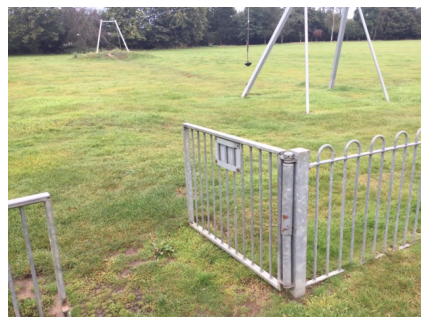
Item is damaged.

Gate leading to cableway is damaged and cracked. Repair / replace.

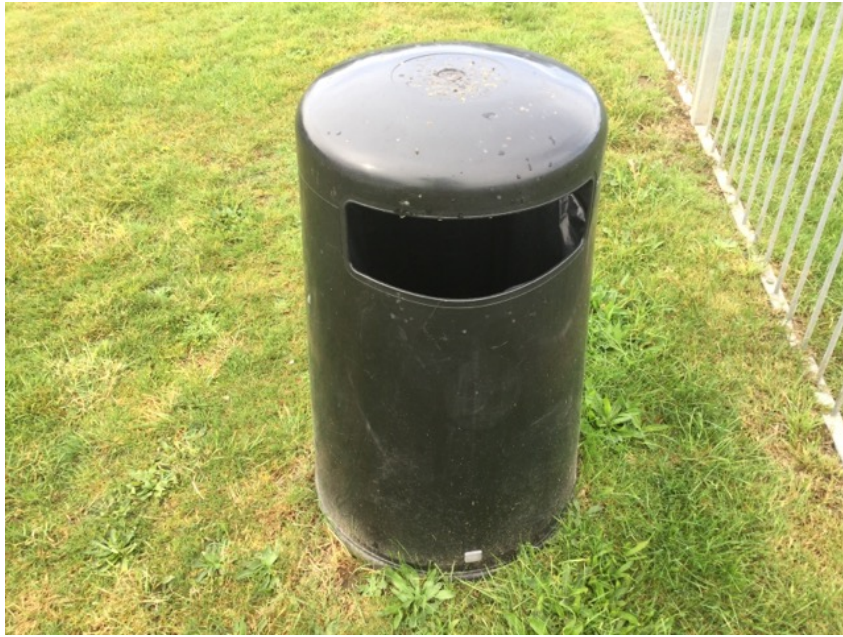
Litter Bins

RoSPA recommends that litter bins should not be closer than 2 m from seats and gates (max of 3 m recommended). If they are too far away they may not be used. If they are too close this may cause nuisance from wasps.

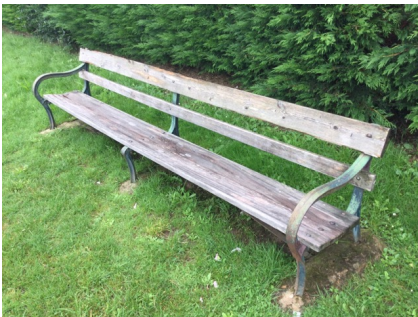
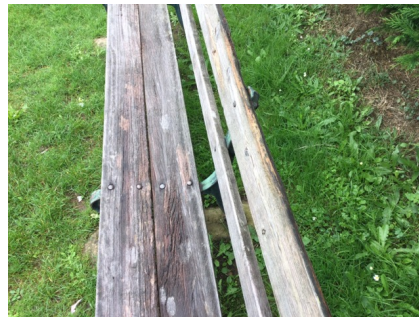
Loose in ground.

Bench adjacent to car park is slightly loose in the ground. Reset.

The material is not in good condition.

Replace.

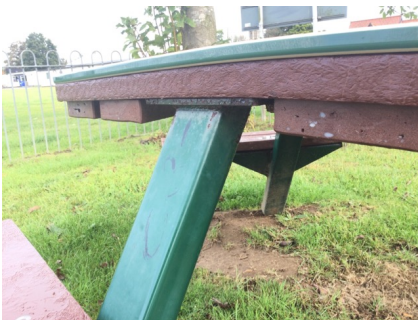
Paintwork is in poor condition.

De-scale back to good base material and coat with lead free paint, using appropriate precautions. Repairs may be necessary where corrosion is severe.

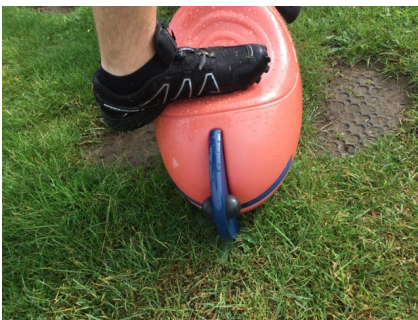
Additional comments are noted below.

Consider adding a dampener under the three bug rocker seats due to a potential crush hazard.

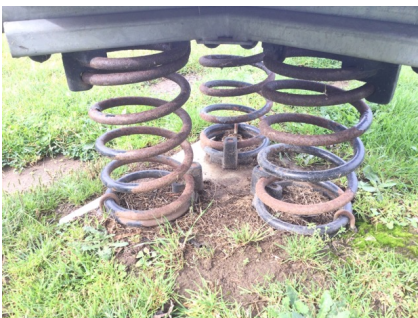
The spring is rusty. These have been known to fail without warning, leading to a collapse of the unit.

Springs have significant amount of rust. Replace. This was notified on the 2022 inspection report.

Replace the item.

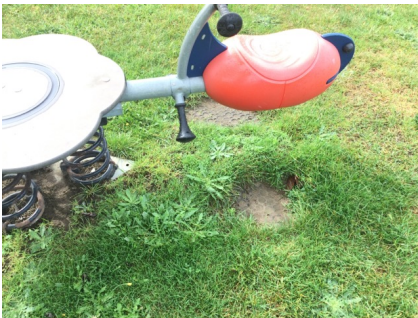
Worn ground areas.

Make good., Build up ground levels to remove trip hazard.

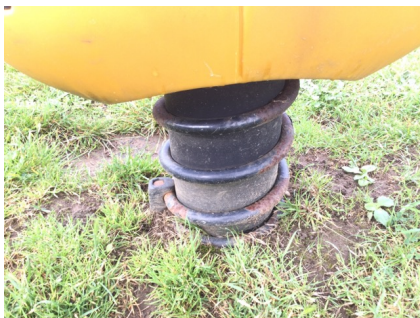
The spring is rusty. These have been known to fail without warning, leading to a collapse of the unit.

Replace.

Replace in the near future.

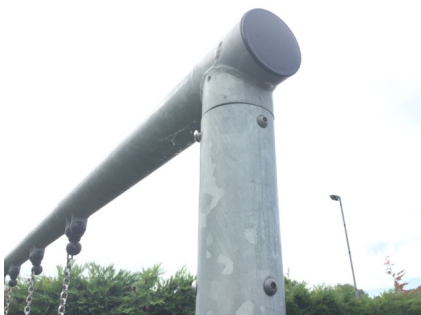
Bolt(s) loose.

Framework bolts are becoming loose. Tighten.

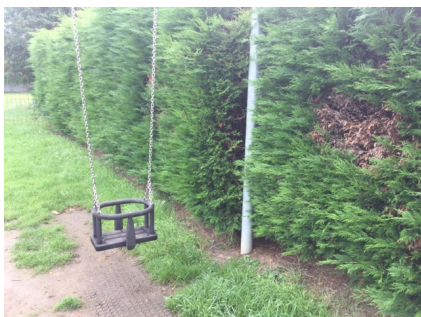
The covers should be removed from the fitting at the top of the chain annually and the shackle bolt should be checked for wear. Check the security of the fittings too.

Replace at 70% of original diameter (30% wear).

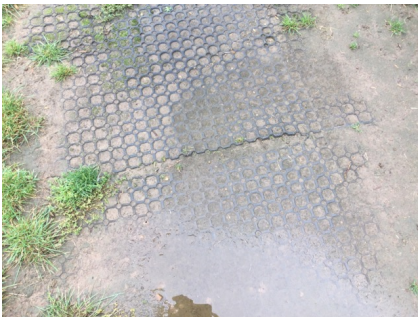
Surface needs repair.

Grass mats are lifting creating a potential trip hazard. Tie down and secure.

Repair.

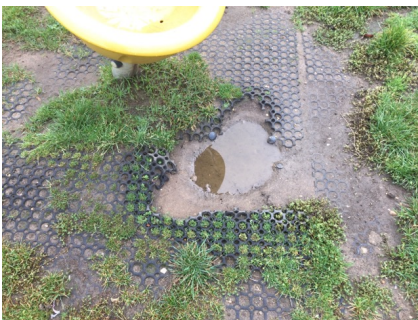
Item is damaged.

Grass mats have been damaged leaving a large surface hole. Repair surface levels and Replace grass mats.

Replace.

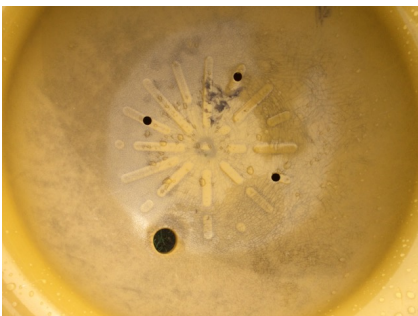
Additional comments are noted below.

Monitor bowl for cracking. Replace when necessary.

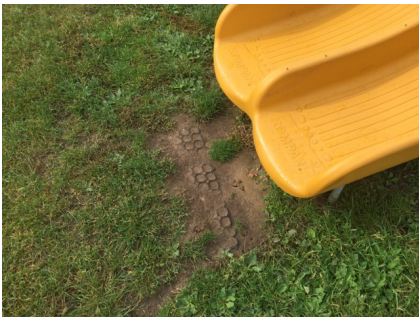
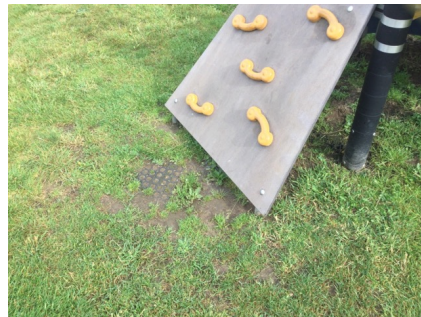
Worn ground areas.

Build up ground levels to remove trip hazard., Make good.

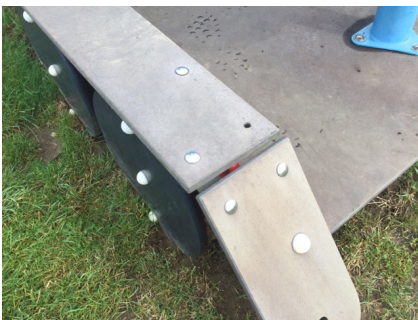
Fixtures loose or missing.

Panel bolts are loose and one is missing. Tighten and replace.
Front steering wheel, gear stick and front platform of the play truck are loose.
Tighten.

Replace., Tighten/replace.

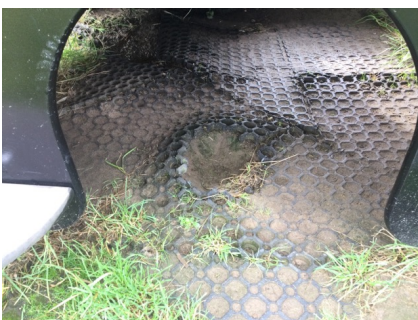
Item is damaged.

Grass mats are damaged under play truck. Replace.

Replace.

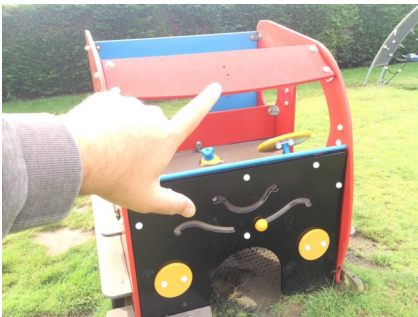
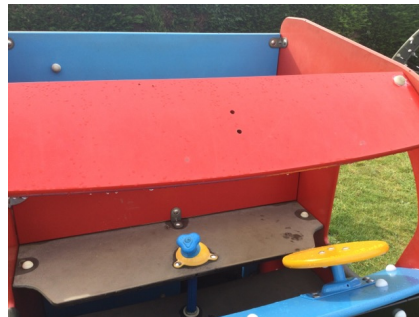
Item has some parts missing.

Play panels sections are missing.

Replace the missing parts.

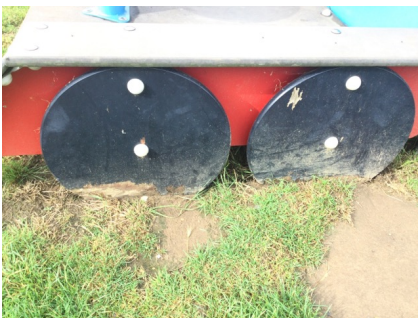
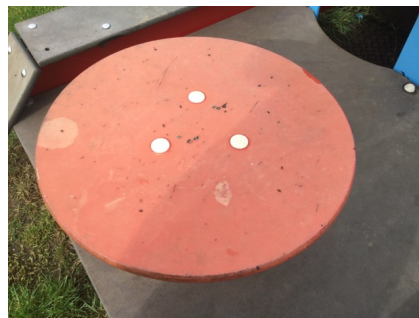
Laminate damaged.

Laminate sections are slightly damaged. Repair.
Consider replacing front laminate and wheel laminates due to levels of damage.
Strimmer damage is present. Prevent further damage.

Rub down and treat damaged edges., Read the notes for further action.

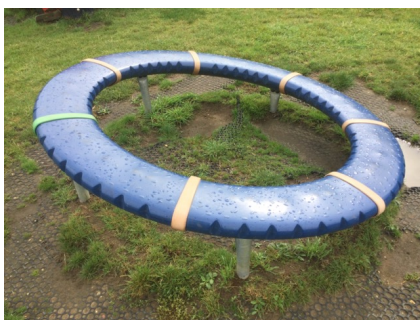
Item is damaged.

Grass mats are damaged around equipment creating potential trip hazards. Replace and secure.

Replace., Repair.

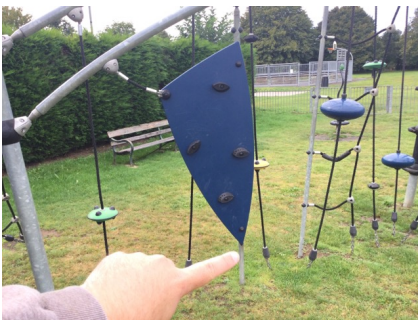
Bolt(s) loose.

Traverse climbing wall section on Multiplay is loose to the metal foundation bar. Tighten.

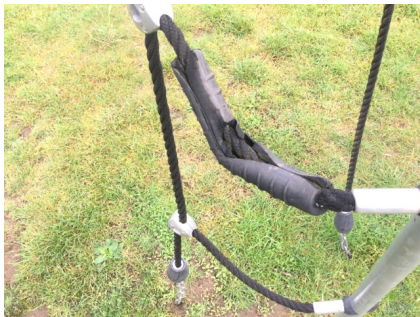
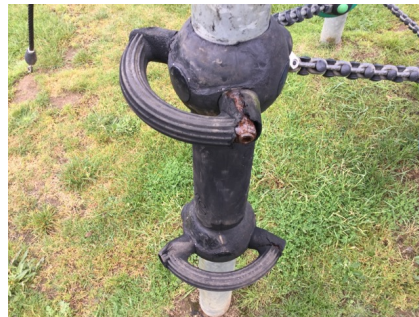
Several rubber covers have degraded exposing metal and rope. Replace.

Replace.

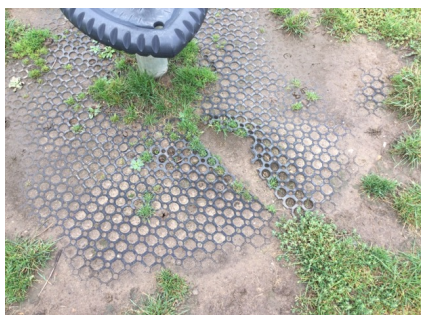
The surface is damaged.

Grass mats are damaged and lifting creating a potential trip hazard. Replace and secure.

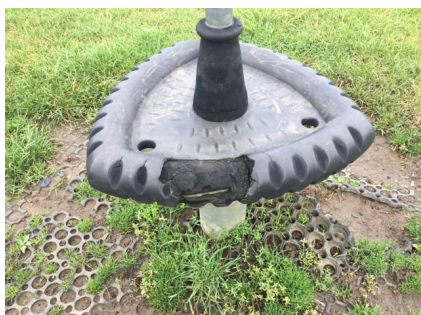
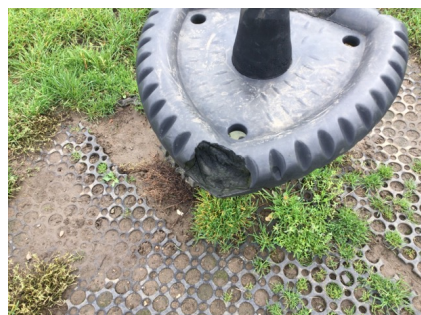
Item is damaged.

Rubber is damaged on platform exposing the metal frame. Replace. This was notified on the 2022 inspection report.

Replace.

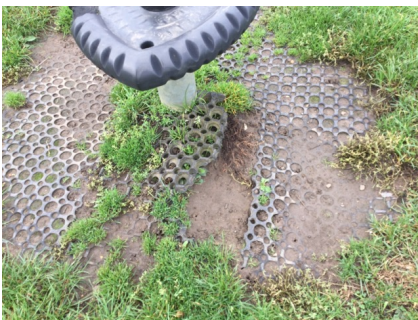
The surface is damaged.

Grass mats are damaged and lifting creating a potential trip hazard. Replace and secure.

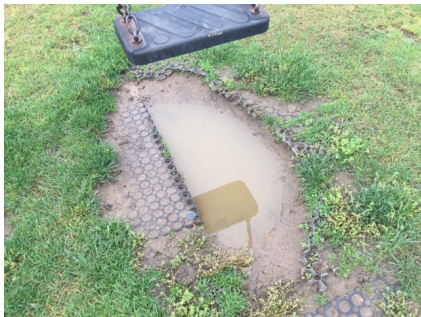
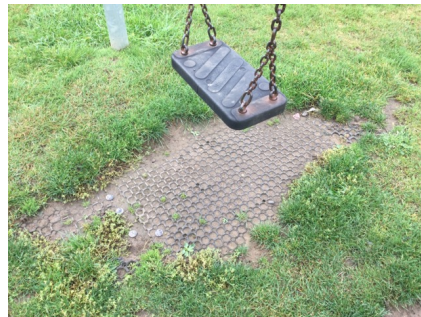
Item is damaged.

Grass mats are damaged and lifting creating a potential trip hazard. Replace.

Replace.

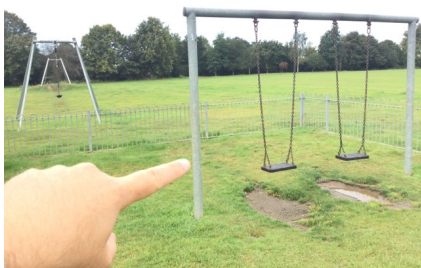
Loose in ground.

Single metal post is slightly loose in the ground. Reset.

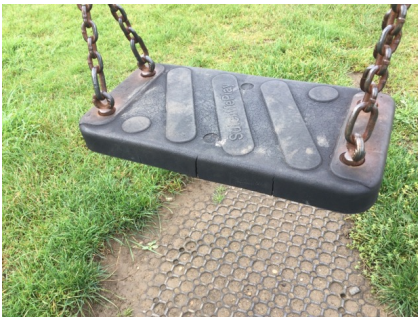
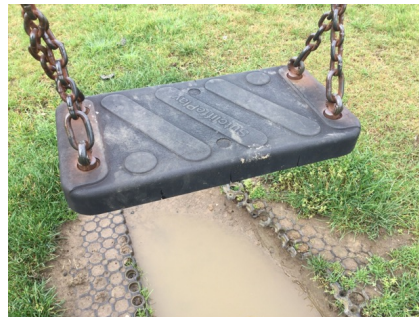
Swing seat rubber is deteriorating / degrading.

Monitor and replace when the metal frame is exposed.

Replace when metal is exposed.

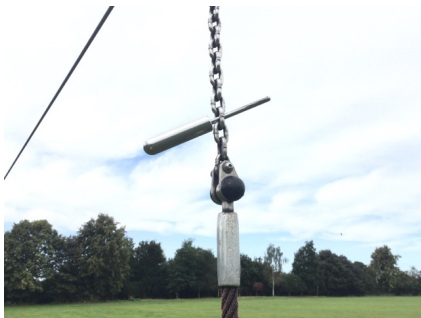
Both Rubber dampeners and springs are loose and can easily move from cable.
Secure.
